Inspection Report - Titaghat weekly inspection clone (Inspection UID - I/TTK/COI/TWI/26/00002)

Inspection Name	Aditya V	Inspection Type	Titaghat weekly inspection clone
Inspection Status	Draft	Site Name	Coimbatore
Asset	NA	Non Oqsha Assets	NA

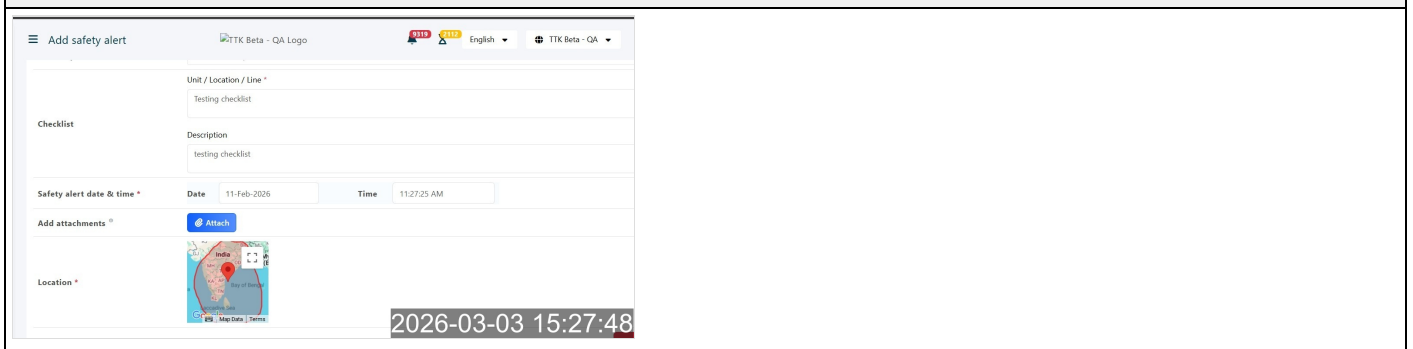
Attachments

1.Vehicles & equipment entering inside has Working warning lights and alarms.: No	Findings/Remarks : NA	2.Workers maintaining safe distances from moving vehicles : No	Findings/Remarks: NA
3.Internal walking surfaces free from potholes, cracks etc.: No	Findings/Remarks: NA	4.Conveyor pulley drive having appropriate cover/guard.: No	Findings/Remarks : NA
5.Chemical binders used have associated Safety Data Sheets: No	Findings/Remarks: NA
